Beaver Pipe Cage 2020 Build a Better Mousetrap Winner

OVERVIEW OF INNOVATION

Town of Niles, NY

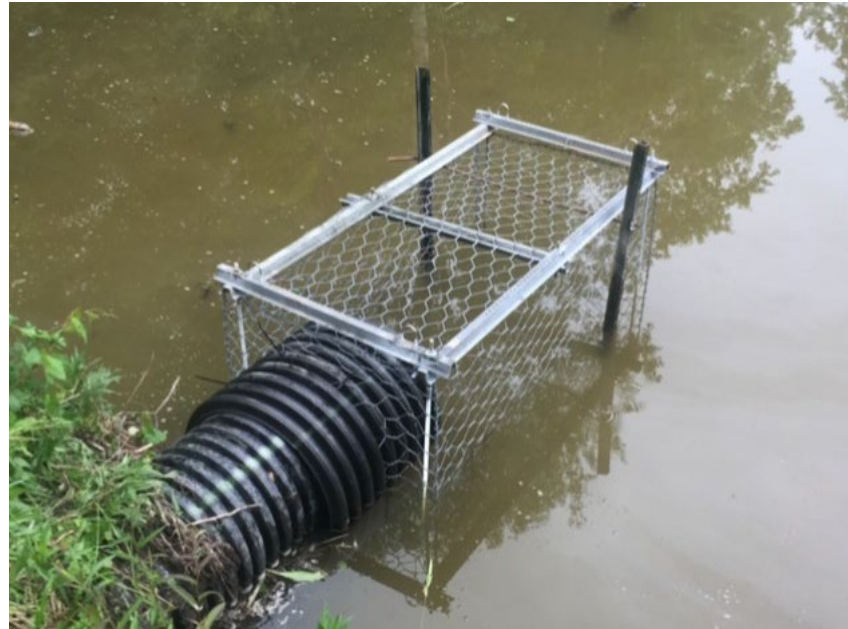
The Town of Niles, New York had a flooding problem along their roadways because of a clogged cross culvert. Highway Department officials found that beavers were packing the culvert with sticks and mud causing water to back up and flood the area. To solve the problem, town highway officials grabbed some unused steel baskets from another job and built a Beaver Pipe cage to keep out the beavers and allow water to flow freely throughout the culvert.

The solution cost the town less than \$500 because they already had the main materials. The Beaver Pipe Cage solved the flooding problems and forced the beavers out of the area.
